**Existing Situation Report**

**BRTS Chowk,**

**Surat**

**Surat Smart City Limited**

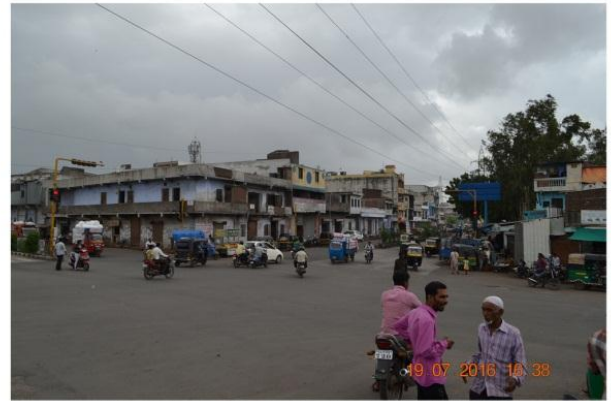
02-CONDITION OF CARRIAGEWAY.JPG

Features	Status as on Date
<b>Carriage Way</b>	<p>The circle lies on the confluence of 24.0 Meter wide road and 60.0 meter wide road. The 24.0 meter wide road is heading towards Bhathena Creek, whereas the 60.0 meter wide road is Parvat Patia road.</p> <p><b>Type of Road:</b> Arterial Road</p> <p><b>Width of ROW:</b> 24.0 meter wide road and 60.0 meter wide road</p> <p><b>Type of Carriageway:</b> Dual carriageway on all side</p> <p><b>Width of Carriageway:</b> The width of carriageway is 10.0 Mtrs on 24.0 Wide meters road</p> <p><b>Lane Marking:</b> There is no Lane Marking</p> <p><b>Number of Marked Lanes:</b> N/A</p> <p><b>Condition of Carriageway:</b> Good (<i>refer photo no: 2, 7, 8</i>)</p>
<b>Speed Regulating</b>	There is no presence of Speed regulating mechanism

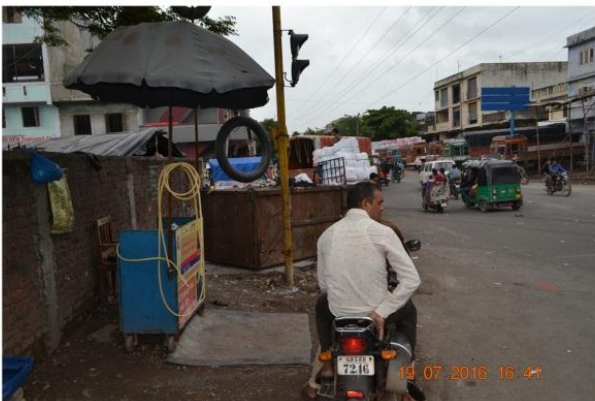
03-GARBAGE DISPOSAL AREA.JPG

<p><b>Foot over bridge / subway:</b> Not available</p> <p><b>Disable friendly facilities:</b> Not available</p>
<b>Street Signage</b>	<p>The street signage's are available on BRTS corridor, Bill boards are present at a height of 8-12 Mtrs. The condition of the signages is maintained. All the signages are visible at night.</p>
<b>Trees and Street Furniture</b>	<p>There is no planned street furniture on the street. Trees are located along the road.</p> <p><b>Dustbins on footpath:</b> Not available</p> <p><b>Has segregation of bio and other waste been done?</b> No</p> <p><b>Trees on footpath/ Median:</b> yes</p> <p><b>Diameter of tree trunk – (1.0- 1.5) Mtrs</b></p> <p><b>Is the height of the tree more than the street light pole?</b> Yes</p> <p><b>Spread of the tree foliage:</b> (0.6-1.0 )meters</p> <p><b>Shrubs on the median:</b> No</p> <p><b>Benches along footpath:</b> Not available</p> <p><b>Are there any billboards along the footpath?</b> Yes</p> <p><b>Obstructions on footpath:</b> Parking, distribution boards and trees are obstructions at certain places. (<i>refer photo no: 8, 3)to depict obstructions on footpath</i>)</p>

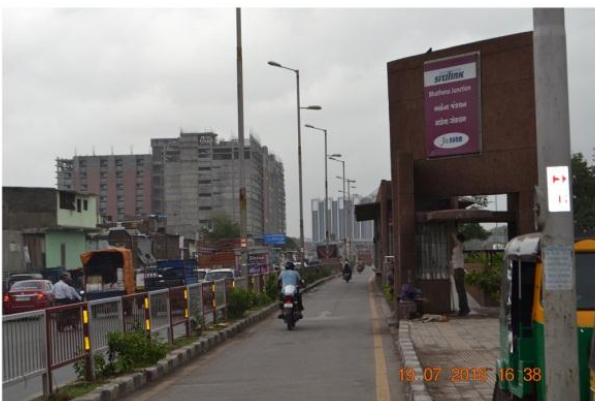
05-SPACING OF LIGHT POLES.JPG

<b>Lighting</b>	<p>The Lighting poles are provided along the median in 24.0 meter wide along median, and 60.0 MTRS along BRTS Corridor</p> <p><b>Spacing of poles:</b> 30 meters</p> <p><b>Height of poles:</b> 8 meters ( refer photo no: 6, 5, 2 )<i>for spacing of light poles</i></p>
<b>Pedestrian Crossings</b>	<p>No Pedestrian Zebra Crossings are provided .</p> <p><b>Interval of pedestrian crossing:</b> Irregular</p> <p><b>Type of crossing:</b> At grade</p> <p><b>Caution signs near pedestrian crossing:</b> Yes</p> <p><b>Priority to pedestrians at junctions:</b> NO</p>

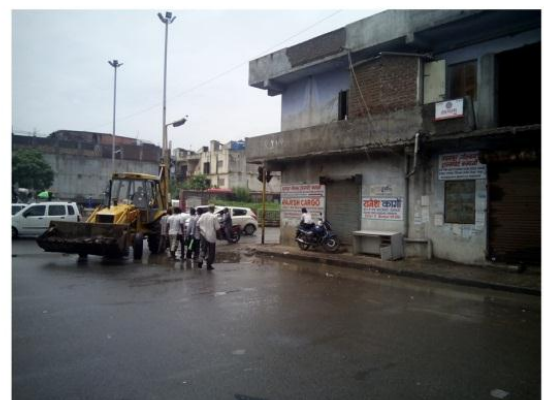
08-FOOTPATH PEDESTRAIN FACILITY.jpg

<b>Mechanism (SRM)</b>	around the Junction
<b>Median Details</b>	<p>The Median is present only on 24.0meter wide Bhatena Creek road. The 60.0 Meter wide road has BRTS corridor.</p> <p><b>Width (cms);</b> 1 mtrs</p> <p><b>Height (cms):</b> (0.4-0.5)mtrs</p> <p><b>Material of median :</b> Cement concrete</p> <p><b>Condition of Median :</b> The median is broken at certain location</p>
<b>Storm Water Drainage Infrastructure</b>	Strom water drainage are present on both the sides of road and are underground. There are grit chambers also available.
<b>Footpath and Pedestrian Facilities</b>	<p>The Footpath is present along the 24.0 meter wide road .</p> <p><b>Width :</b> 1.2 Meters</p> <p><b>Height:</b> (0.18 - 0.20) Meters</p> <p><b>Material Used:</b> The material used is cement concrete.</p> <p><b>Texture:</b> The texture is rough and is in broken condition</p> <p>The footpath has no kerb stone along the footpath. The footpath is obstructed by Electrical distribution board, Property owners, parking and trees.</p> <p>( refer photo no: 8 )</p>
